Tree Inventory Report at 2801 Pinole Valley Road, Pinole, California

Tree Inventory and Observations for 2801 Pinole Valley Road (APN 360-010-029-5)

TREE INVENTORY PLAN

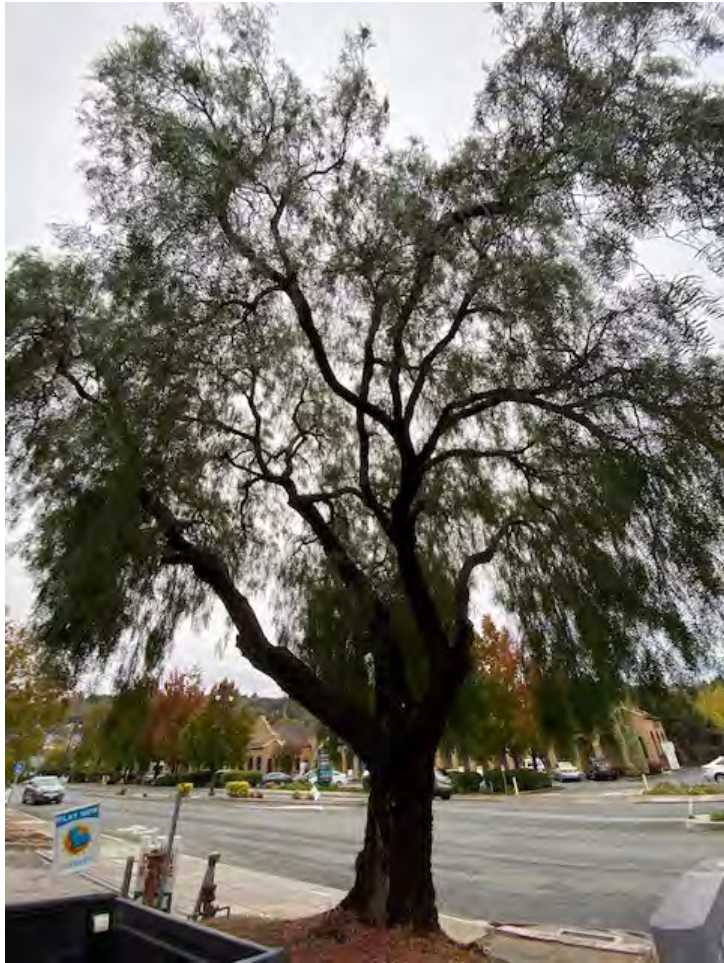
Tree #	SPECIES	DIA	S	H	RV	OBSERVATIONS/RECOMMENDATIONS	P	SAVE/ REMOVE
1	California Pepper, <i>Schinus molle</i>	26	3	3.5	4	Located within the planting strip between the sidewalk along Pinole Valley Road and the front parking lot. Surface roots. Utility box at root crown. Girdling roots ¹ . Proposed site improvements show tree removal.	P	R
2	California Pepper, <i>Schinus molle</i>	15.5	2.5	2.5	3	Located within the planting strip between the sidewalk along Pinole Valley Road and the front parking lot. Hollow cavity at root crown; leans 45 degrees NE. Sparse canopy, woodpecker damage and codominant branch union 6' above grade with surface roots. Proposed site improvements show tree removal.		R
3	California Pepper, <i>Schinus molle</i>	11	2.5	3	3	Located within the planting strip between the sidewalk along Pinole Valley Road and the front parking lot. Lopsided canopy. Proposed site improvements show tree removal.		R

Tree #1, a 26" California pepper (to be removed and replaced)

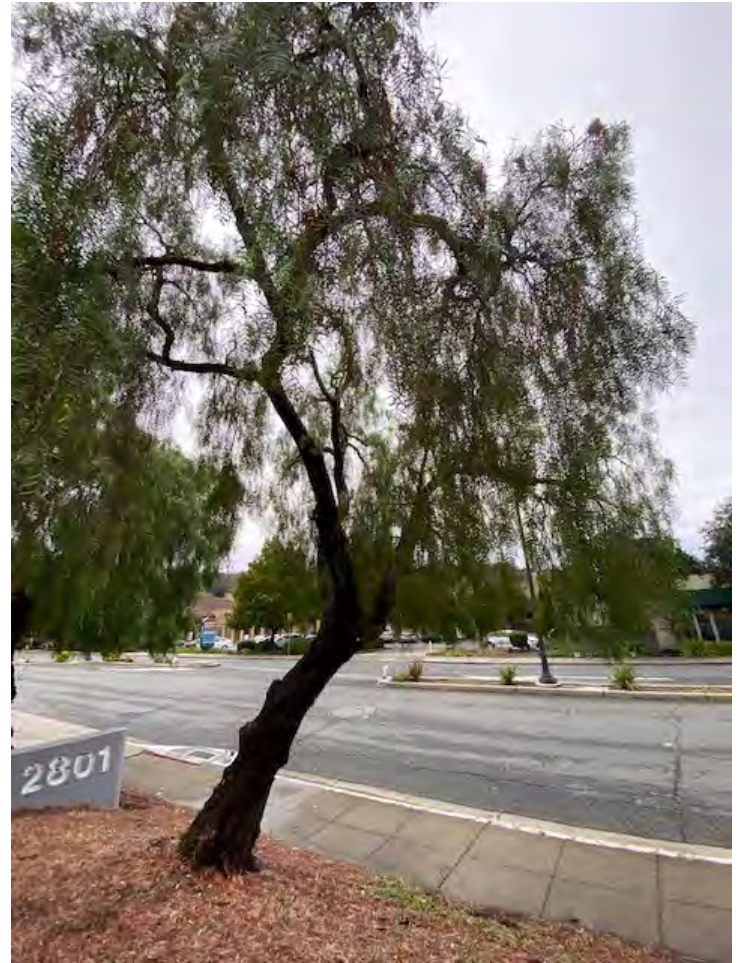
Tree #2, a 15.5" California pepper (to be removed and replaced)

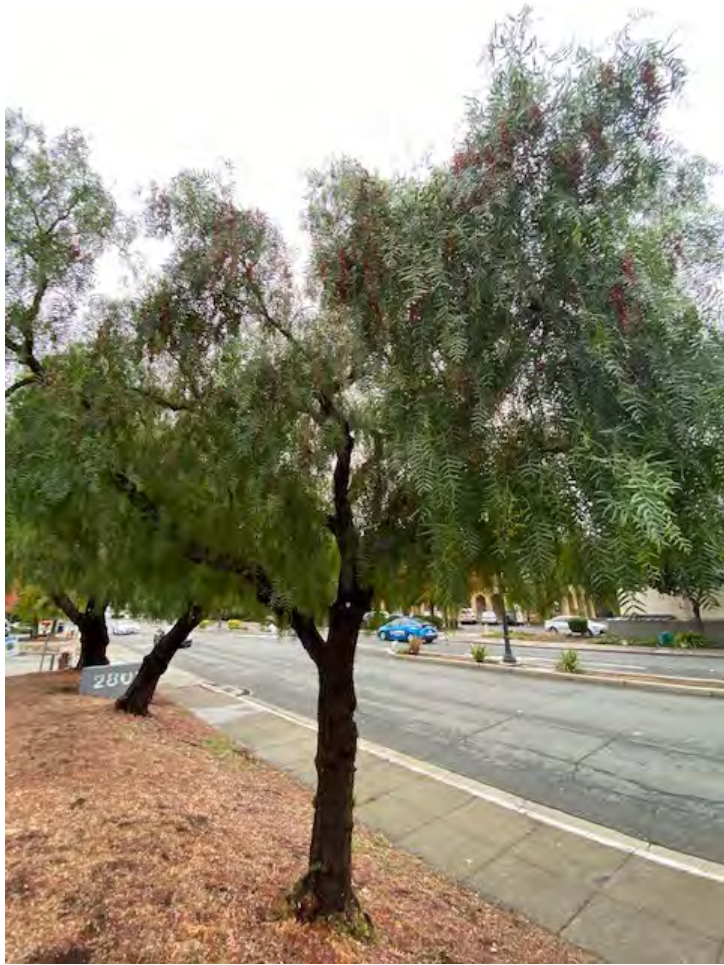
Tree #3, an 11" California pepper (to be removed and replaced)

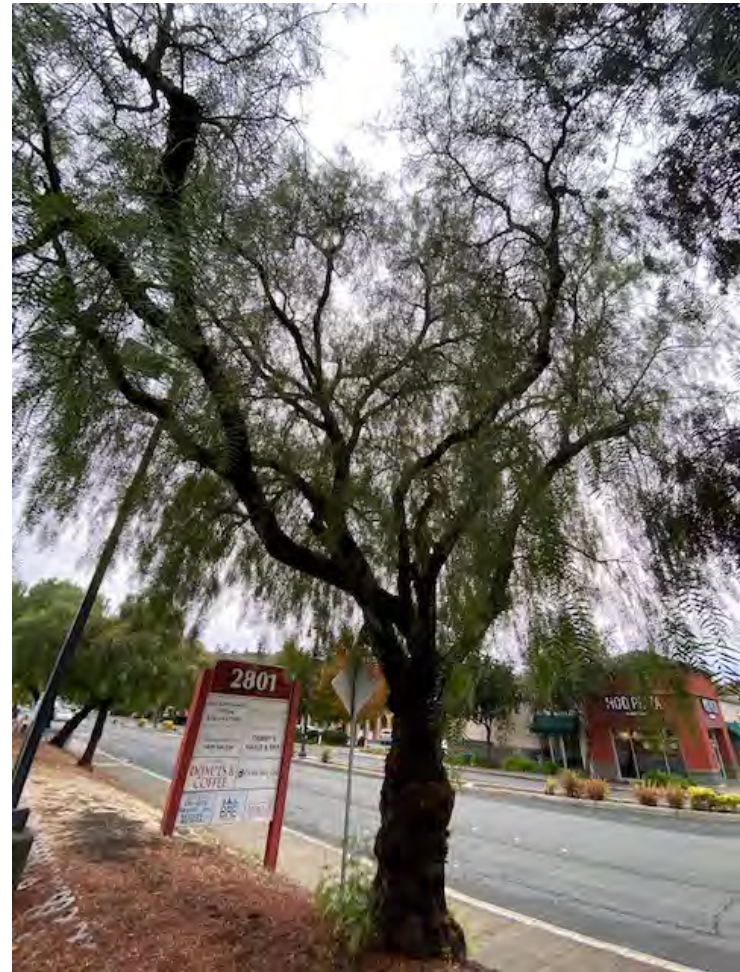
4	California Pepper, <i>Schinus molle</i>	20	3	3.5	3	Located within the planting strip between the sidewalk along Pinole Valley Road and the front parking lot. Sucker growth at root crown and at pruned leaders. Poor branch union at 6'-6" above grade, where central leader divides in 4. Proposed site improvements show tree removal.	P	R
5	California Pepper, <i>Schinus molle</i>	22, 9	3	3.5	4	Located within the planting strip between the sidewalk along Pinole Valley Road and the front parking lot. Multi-trunked. Poor branch union at 5' above grade with included bark ² . Surface roots. Poor branch union at 4' above ground with included bark ² . Proposed site improvements show tree removal.	P	R
6	Cherry, <i>Prunus</i> <i>sp.</i>	10	2.5	3	3	Located at the center breezeway at the existing commercial building. Poor branch union at 4' above ground, where central leader divides in 4. Proposed site improvements require removal.		R

Tree #4, a 20" California pepper (to be removed and replaced)

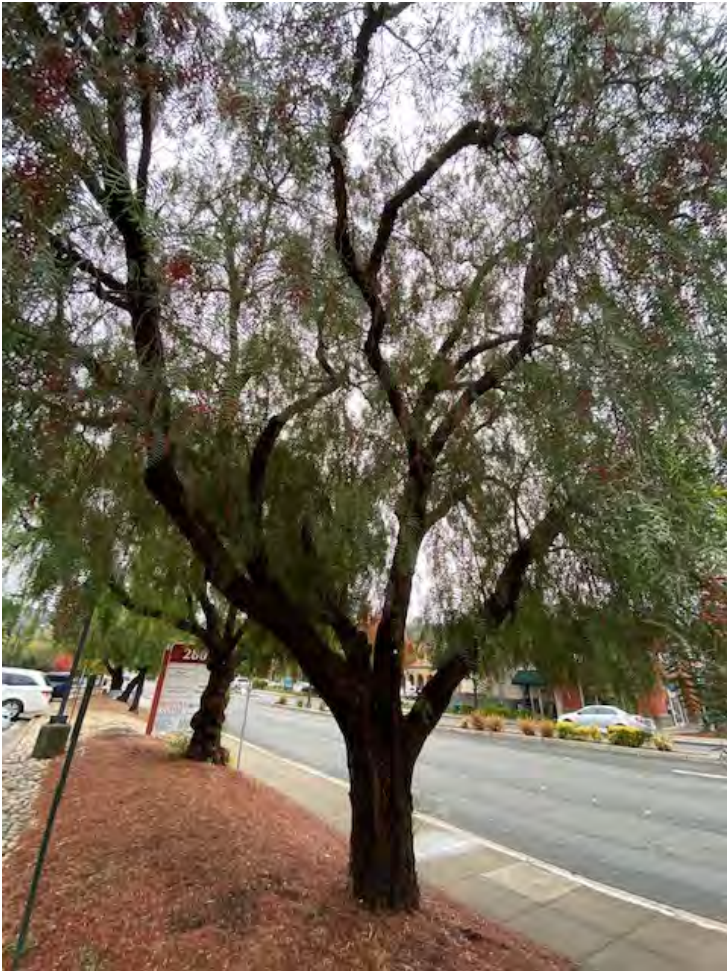
Tree #5, an 22", 9" California pepper (to be removed and replaced)

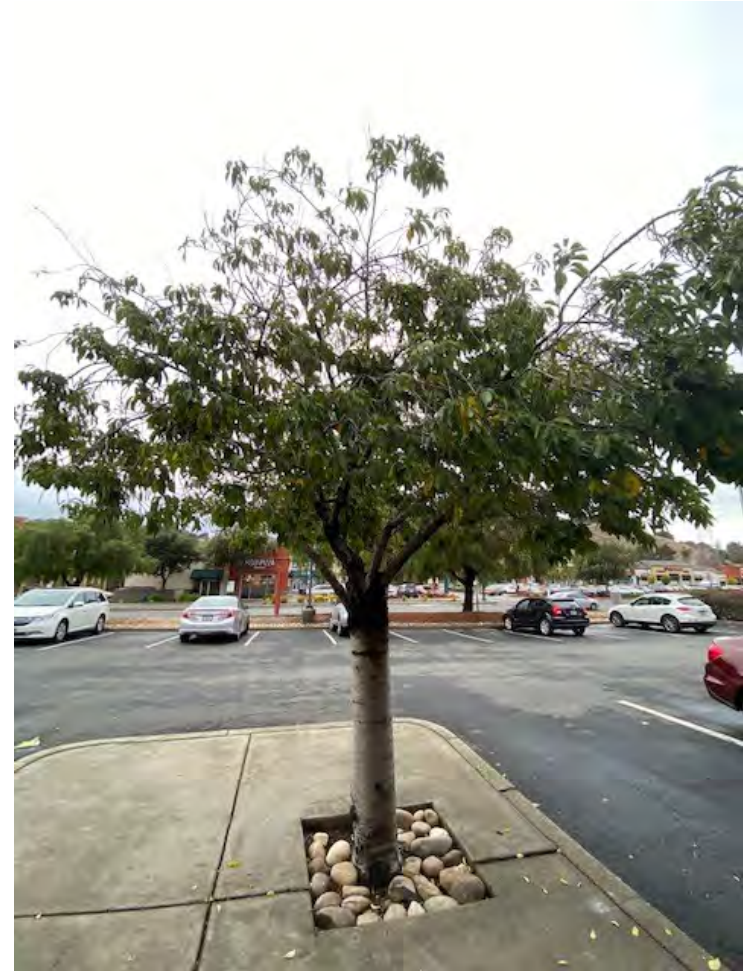
Tree #6, a 10" cherry (to be removed)

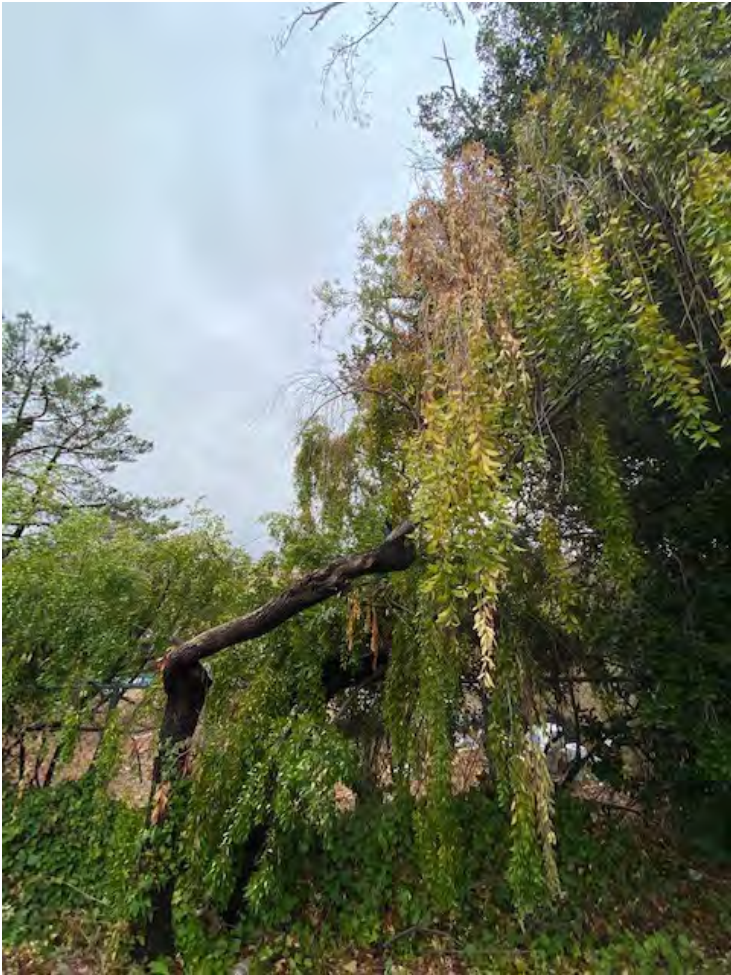
Tree #	SPECIES	DIA	S	H	RV	OBSERVATIONS/RECOMMENDATIONS	P	SAVE/ REMOVE
15	Mayten, <i>Maytenus boaria</i>	7	1.5	1.5	1	Not included on original survey. Located southwestern property line behind neighboring convenience store. Ivy growing at lower trunk. Leans into one side at 5' above ground. Removal recommended.		R
16	Mayten, <i>Maytenus boaria</i>	9.5, 6	3	2	2	Ivy grows at base and through canopy. Significant deadwood. Included bark ² . Site improvements require removal.		R
17	Raywood ash, <i>Fraxinus augustifolia</i> 'Raywood'	~22	2.5	3	3	Located along the southern property line. Ivy at base and canopy. Dead ivy in canopy. Moderate to significant die back. Poor branch union at 9' above grade. Central leader divides into 4. Site improvements require removal.	P	R
18	Raywood ash, <i>Fraxinus augustifolia</i> 'Raywood'	15.5	2.5	3.5	2.5	Located along the southern property line. Poor branch union at 6' above ground. Leader divides into 3, with included bark. Dead ivy. Moderate to significant dead wood. Fractured 12" leader at 9' above ground. Site improvements require removal.		R

Tree #15 a Mayten in severe decline (to be removed and replaced)

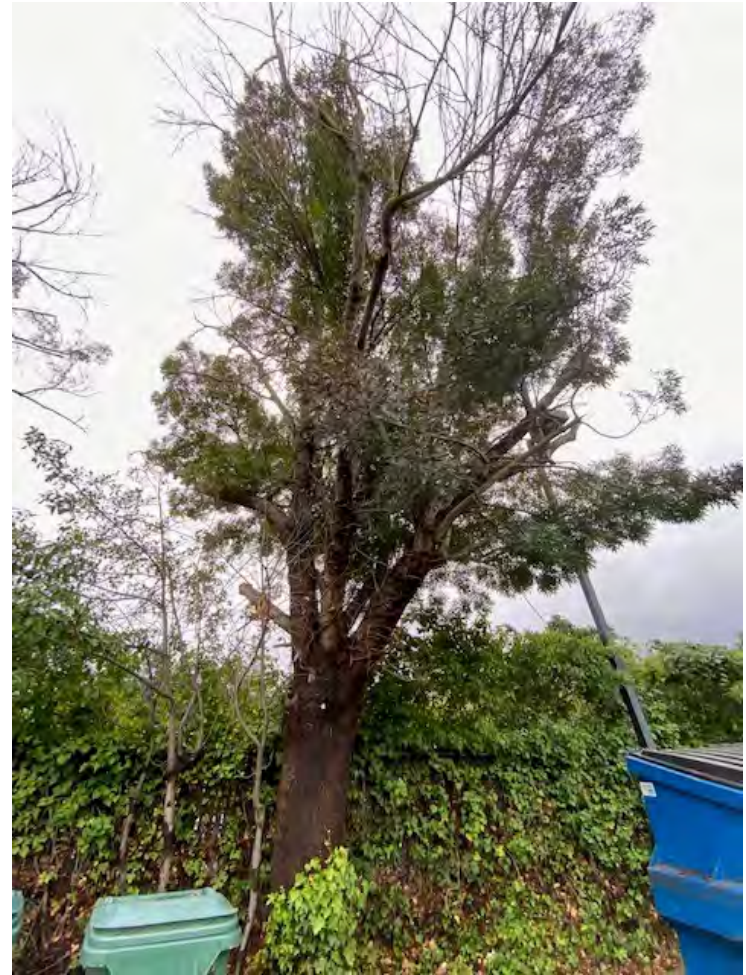
Tree #17 a Raywood ash in decline (to be removed and replaced)
