**CITY OF PINOLE  
SEWER MASTER PLAN  
MAY 2008**

**SEWER MASTER PLAN**

**CITY OF PINOLE**  
**SEWER COLLECTION SYSTEM**  
**MASTER PLAN**

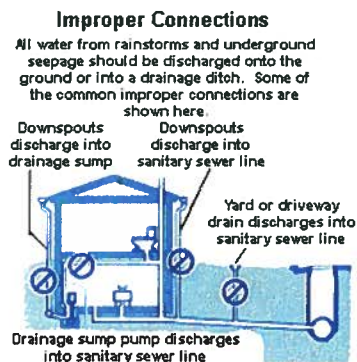
Figure ES - 2 Improper Connections

- Based on the increased flow rates in Basin 6 (Old Downtown), Smoke Testing was performed to identify improper connections (See Figure ES-2) that contribute inflow.
- The Smoke Testing positively identified locations of inflow.
- The majority of inflow defects identified were on private laterals.
- No direct connections to the City's storm drain system were observed.
- A few manhole covers positively indicated inflow potential. See Figure ES-4.

- The City should completely smoke test the system during Dry Weather during the next year. Subsequent years would inspect 20% of the system per year.
- The defects identified in the smoke testing program should be eliminated.
- The City should promulgate regulations for proper operation and maintenance of private service laterals with special emphasis on the removal of inflow defects.

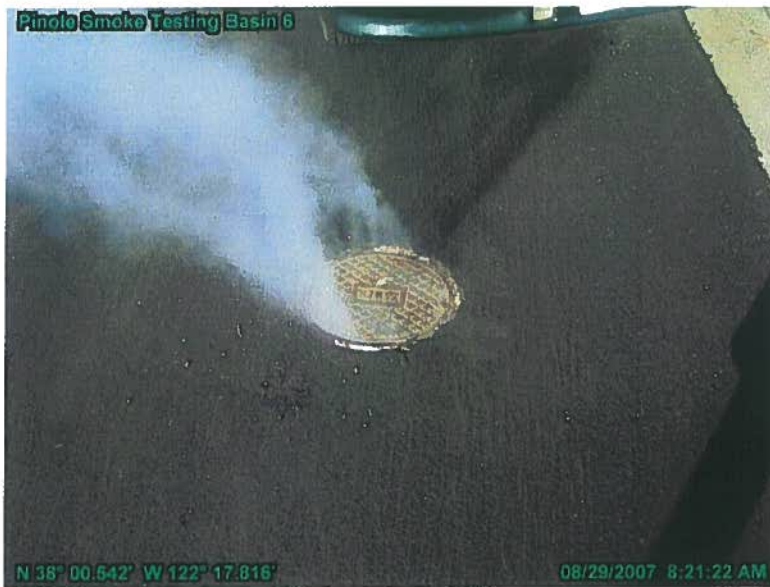
Figure ES - 4 Smoke Testing – Manhole  
If smoke can get out, then rain can get in.

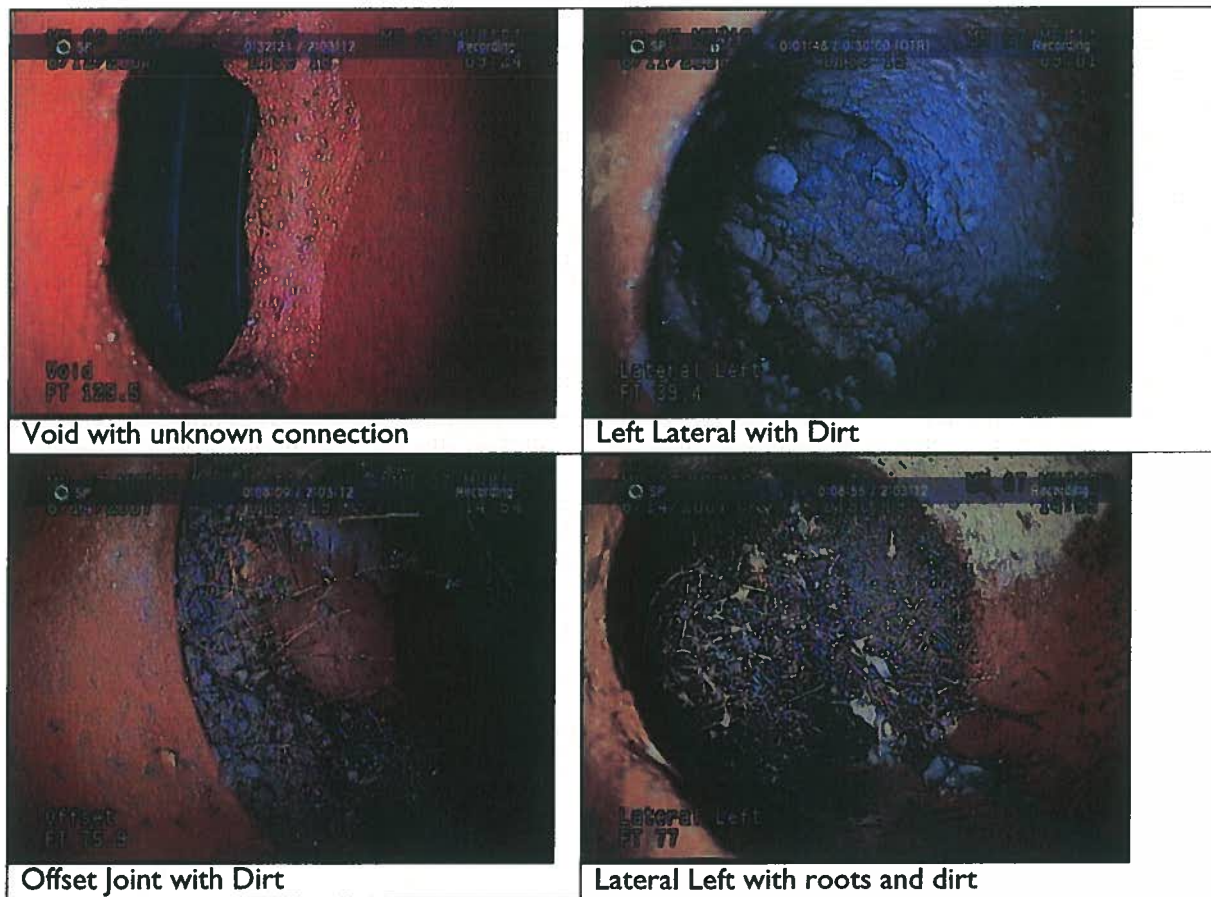
Figure 6-7 CCTV Defects Basin 5 (Meadows)

- Based on the increased flows in Basin 5 (Meadows), TV inspections were performed.
- The TV inspections revealed that much of the pipe was in poor condition, with cracked pipes, root intrusions (See Figure ES-3), and offset joints.
- Most of the roots observed have grown into the collection system through private lateral connections.
- Recent lining projects appear to be in fair condition.
- Minimal active infiltration (leaking) was observed due to dry weather conditions and lowered ground water levels.

- The City should fund, schedule and implement a program that CCTV inspects 100% of the system in the first year with in-house forces. Subsequent years would inspect 20%.
- Document and implement processes for recording, storing and securing CCTV data.
- Short term repairs/rehabilitation needs are listed and should be accomplished (2008).

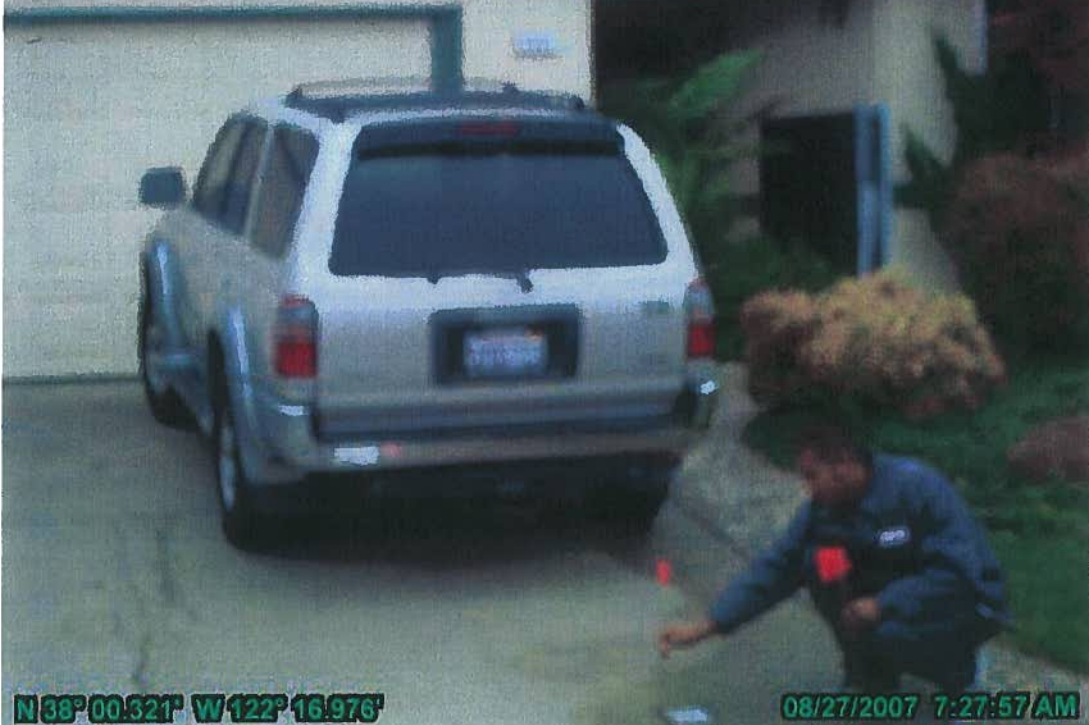
Defect 1 - 2638 Alice - driveway drain

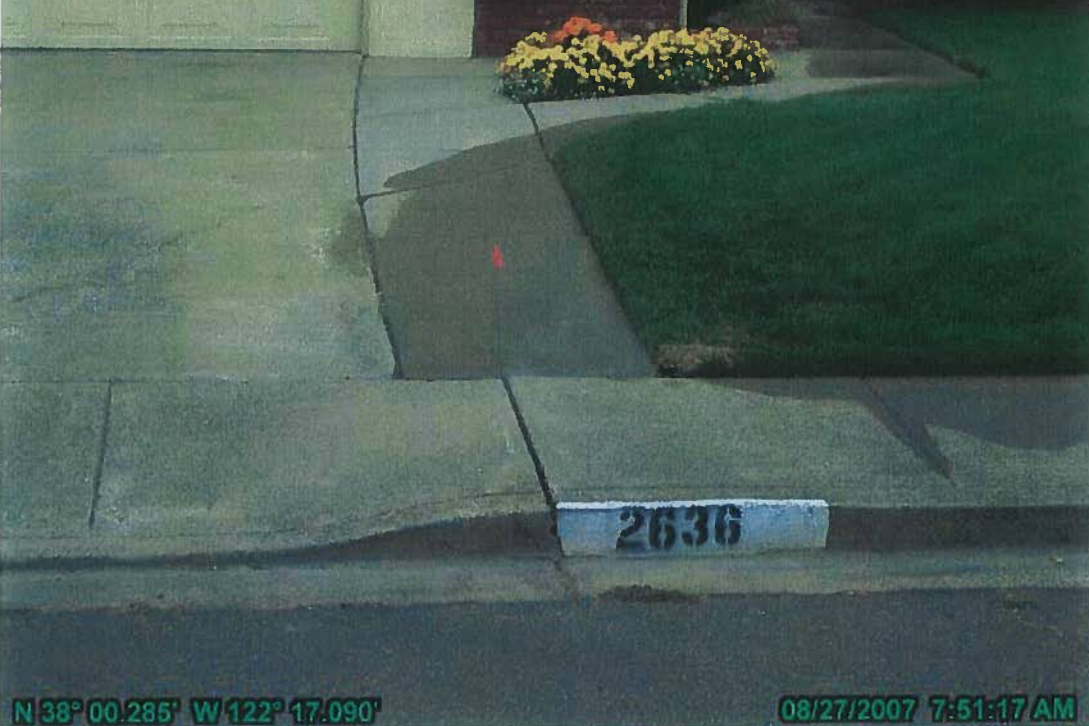
Defect 2 - 2636 Francis - sidewalk

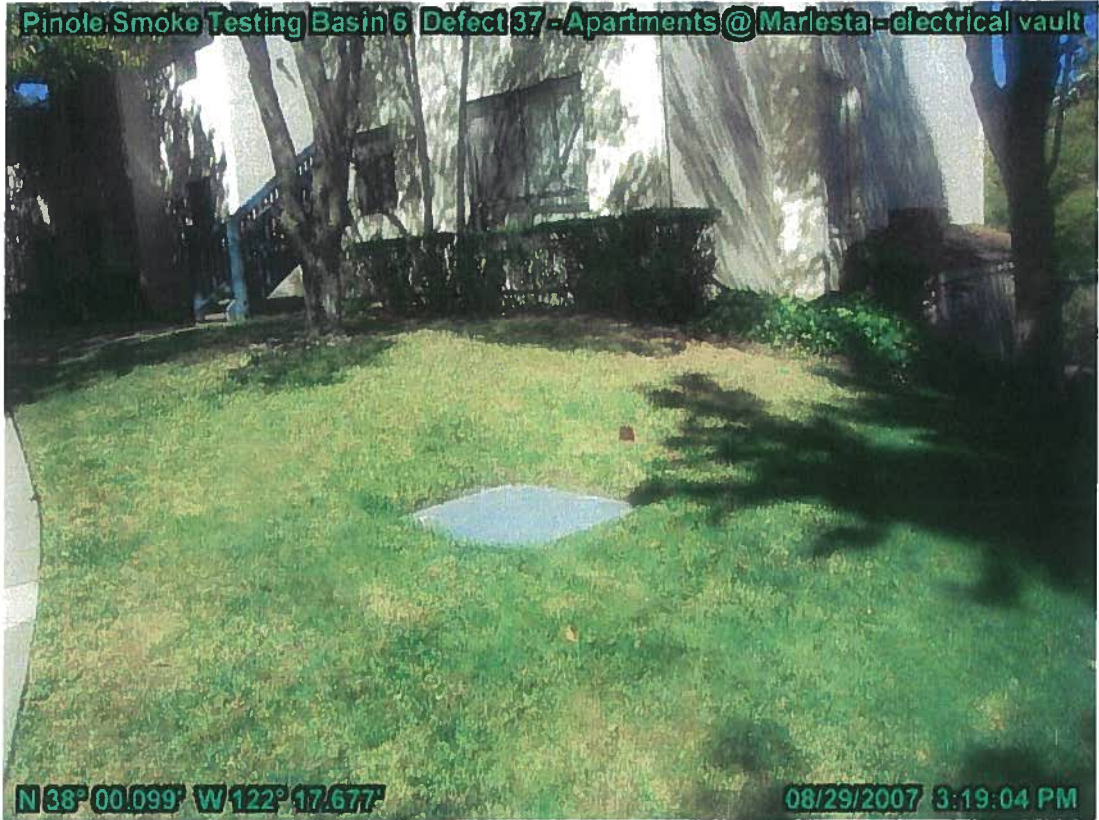
Pinole Smoke Testing Basin 6 Defect 37 - Apartments @ Marlesta - electrical vault
