**Pinole Square Project
CalEEMod Results
Existing Development**

TYPE OF SERVICES	Design-Level Geotechnical Investigation
PROJECT NAME	Pinole Square Shopping Center
LOCATION	1421 Tara Hills Drive Pinole, California
CLIENT	Hillsboro Properties, Inc.
PROJECT NUMBER	856-1-6
DATE	October 31,2019

Type of Services	Design-Level Geotechnical Investigation
Project Name	Pinole Square Shopping Center
Location	1421 Tara Hills Drive Pinole, California
Client	Hillsboro Properties, Inc.
Client Address	1300 South El Camino Real, Suite 525 San Mateo, CA
Project Number	856-1-6
Date	October 31, 2019

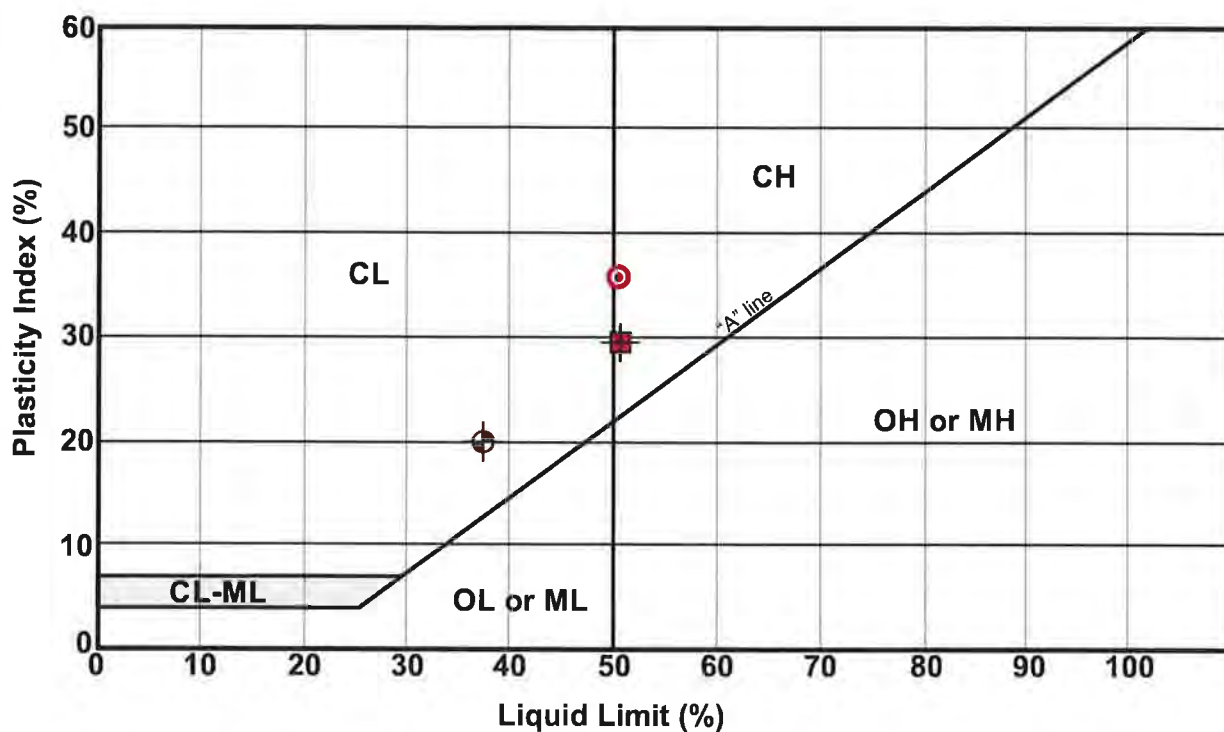
Plasticity Index (ASTM D4318) Testing Summary

Symbol	Boring No.	Depth (ft)	Natural Water Content (%)	Liquid Limit (%)	Plastic Limit (%)	Plasticity Index	Passing No. 200 (%)	Group Name (USCS - ASTM D2487)
⊗	EB-2	4.0	31	38	18	20	—	Lean Clay with Sand (CL) [Fill]
⊠	EB-3	2.0	36	51	22	29	—	Fat Clay with Sand (CH) [Fill]
⊙	EB-10	2.0	27	51	15	36	—	Fat Clay with Sand (CH) [Fill]

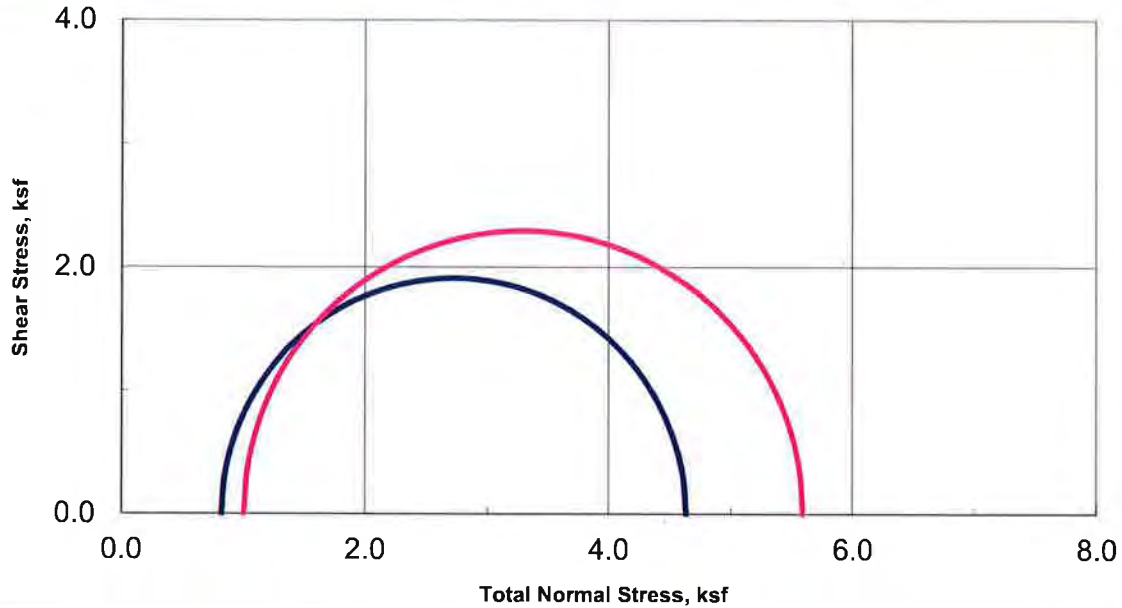
Unconsolidated-Undrained Triaxial Test ASTM D2850

Undrained-Unconsolidated Triaxial Shear Strength: The undrained shear strength was determined on two relatively undisturbed sample(s) by unconsolidated-undrained triaxial shear strength testing (ASTM D2850). The results of this test are included as part of this appendix.

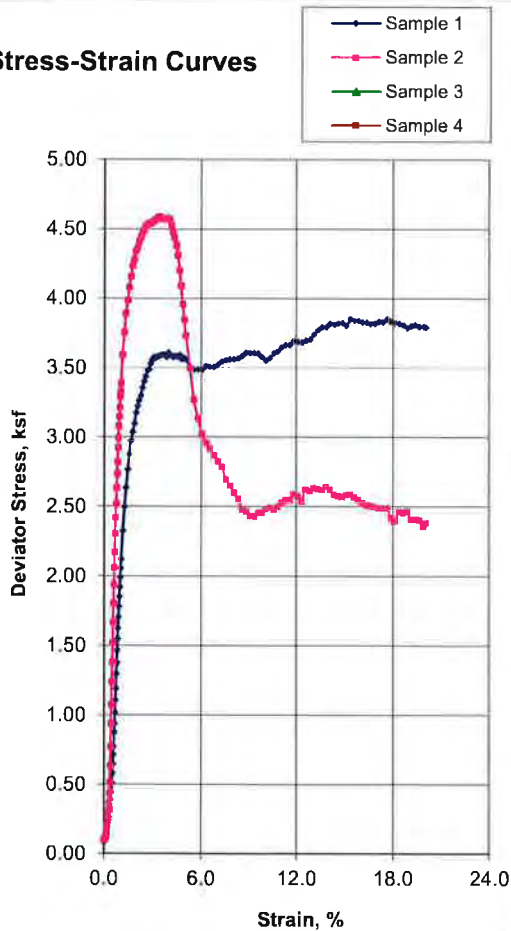
Stress-Strain Curves

1	2	3	4
Moisture %	30.5	38.9		
Dry Den,pcf	88.1	81.8		
Void Ratio	0.912	1.061		
Saturation %	90.1	99.1		
Height in	5.03	5.01		
Diameter in	2.39	2.41		
Cell psi	5.7	6.9		
Strain %	15.00	3.34		
Deviator, ksf	3.822	4.591		
Rate %/min	1.00	1.00		
in/min	0.050	0.050		
Job No.:	640-1358			
Client:	Cornerstone Earth Group			
Project:	856-1-6			
Boring:	EB-7	EB-7		
Sample:	4B	5B		
Depth ft:	9.5	14.0

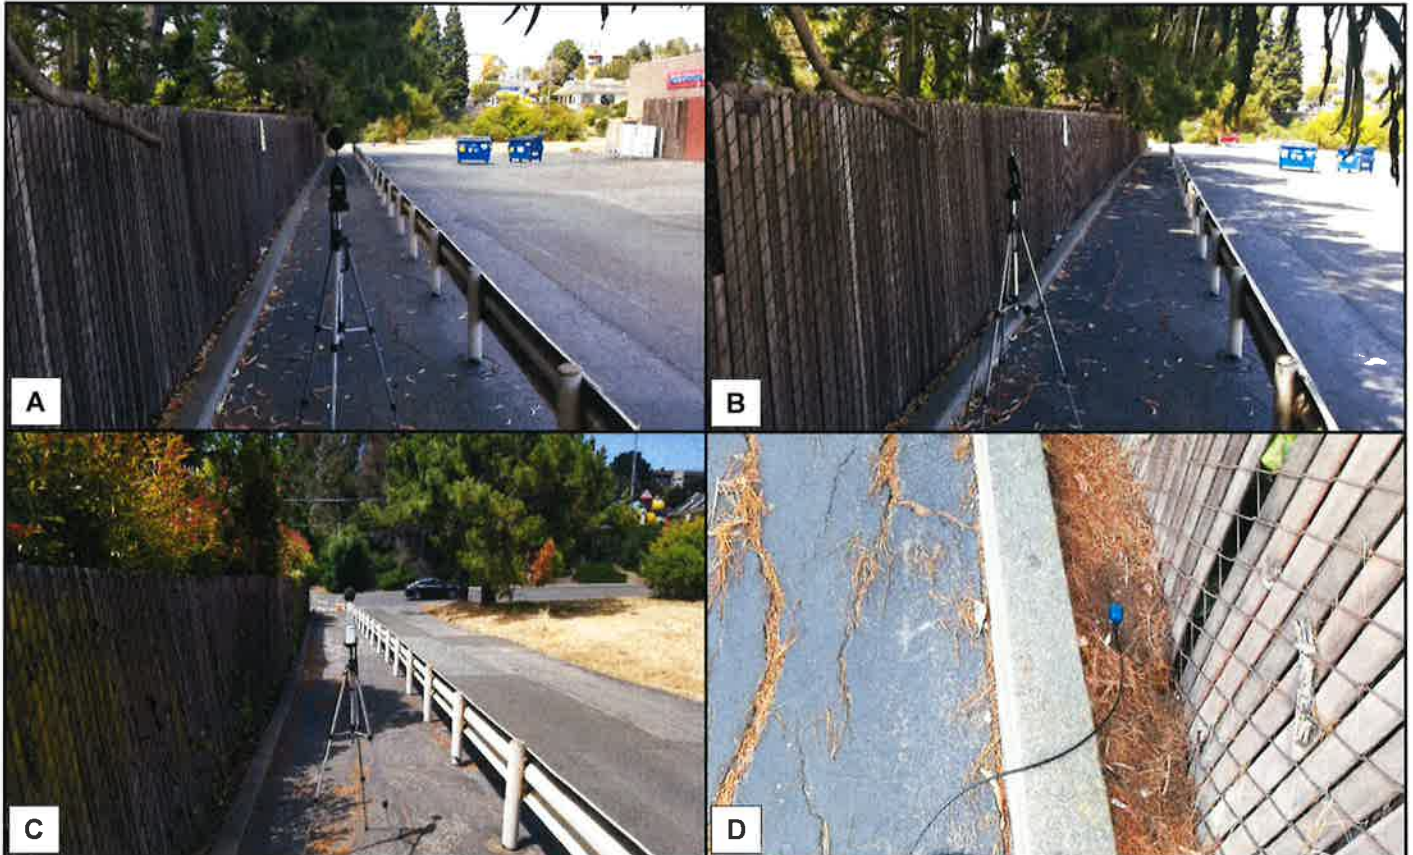
- A: ST-1: Noise survey equipment along west end of project area, looking north towards Tara Hills Drive (37°59'42.01" N, 122°18'20.76" W)
 B: ST-1: Vibration survey equipment along west end of project area, looking north towards Tara Hills Drive (37°59'42.01" N, 122°18'20.76" W)
 C: ST-2: Noise survey equipment along west end of project area, looking north towards Tara Hills Drive (37°59'43.60" N, 122°18'20.70" W)
 D: ST-2: Vibration survey equipment along west end of project area, looking north towards Tara Hills Drive (37°59'43.60" N, 122°18'20.70" W)

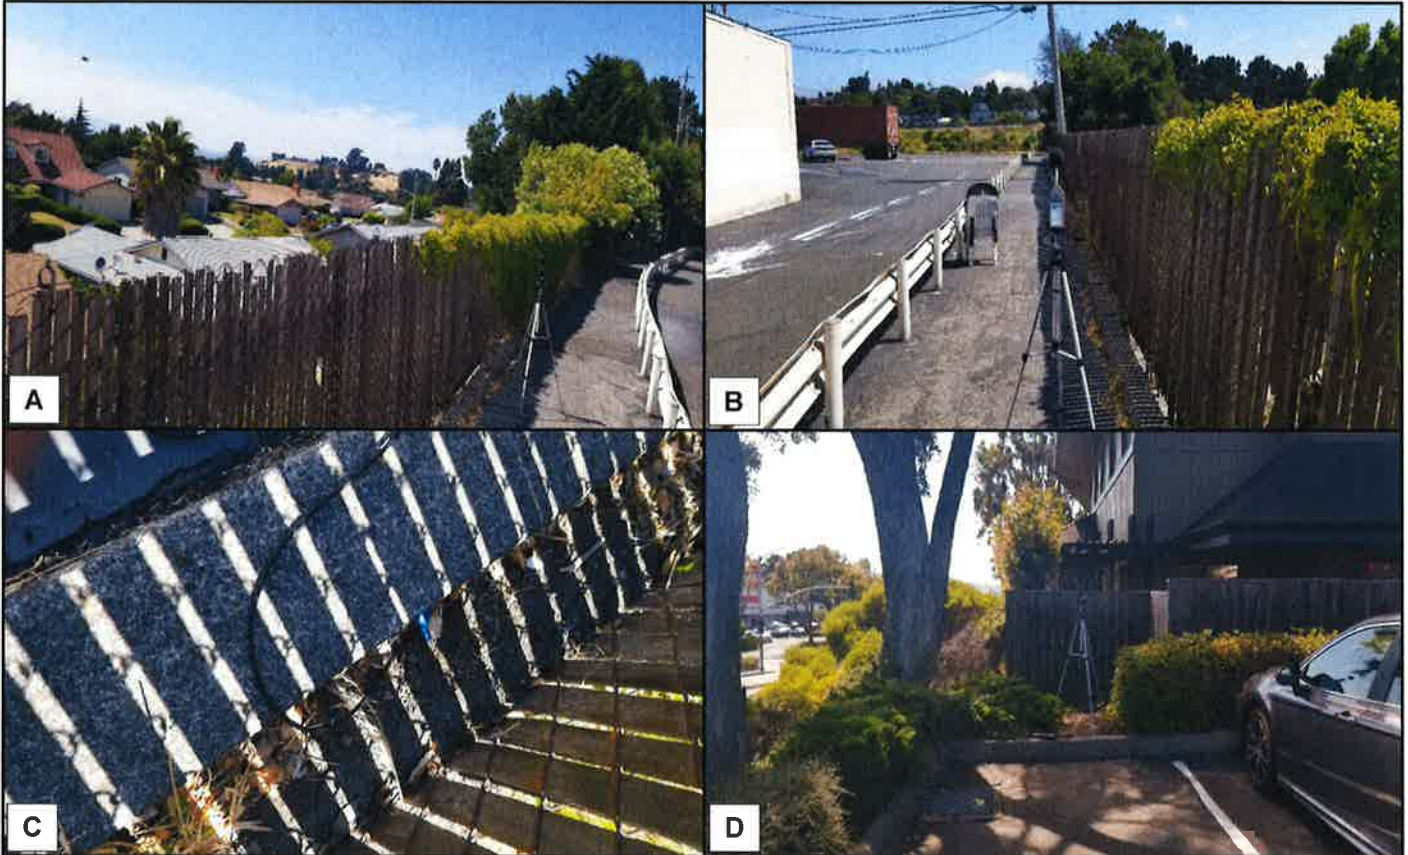
- A: ST-3: Noise survey equipment along west end of project area, looking northwest towards residences (37°59'39.44" N, 122°18'20.95" W)
 B: ST-3: Noise survey equipment along west end of project area, looking south towards Interstate 80 (37°59'39.44" N, 122°18'20.95" W)
 C: ST-3: Vibration survey equipment along west end of project area (37°59'39.44" N, 122°18'20.95" W)
 D: ST-4: Noise and vibration survey equipment at 1500 Tara Hills Drive facing west (37°59'44.27" N, 122°18'12.91" W)

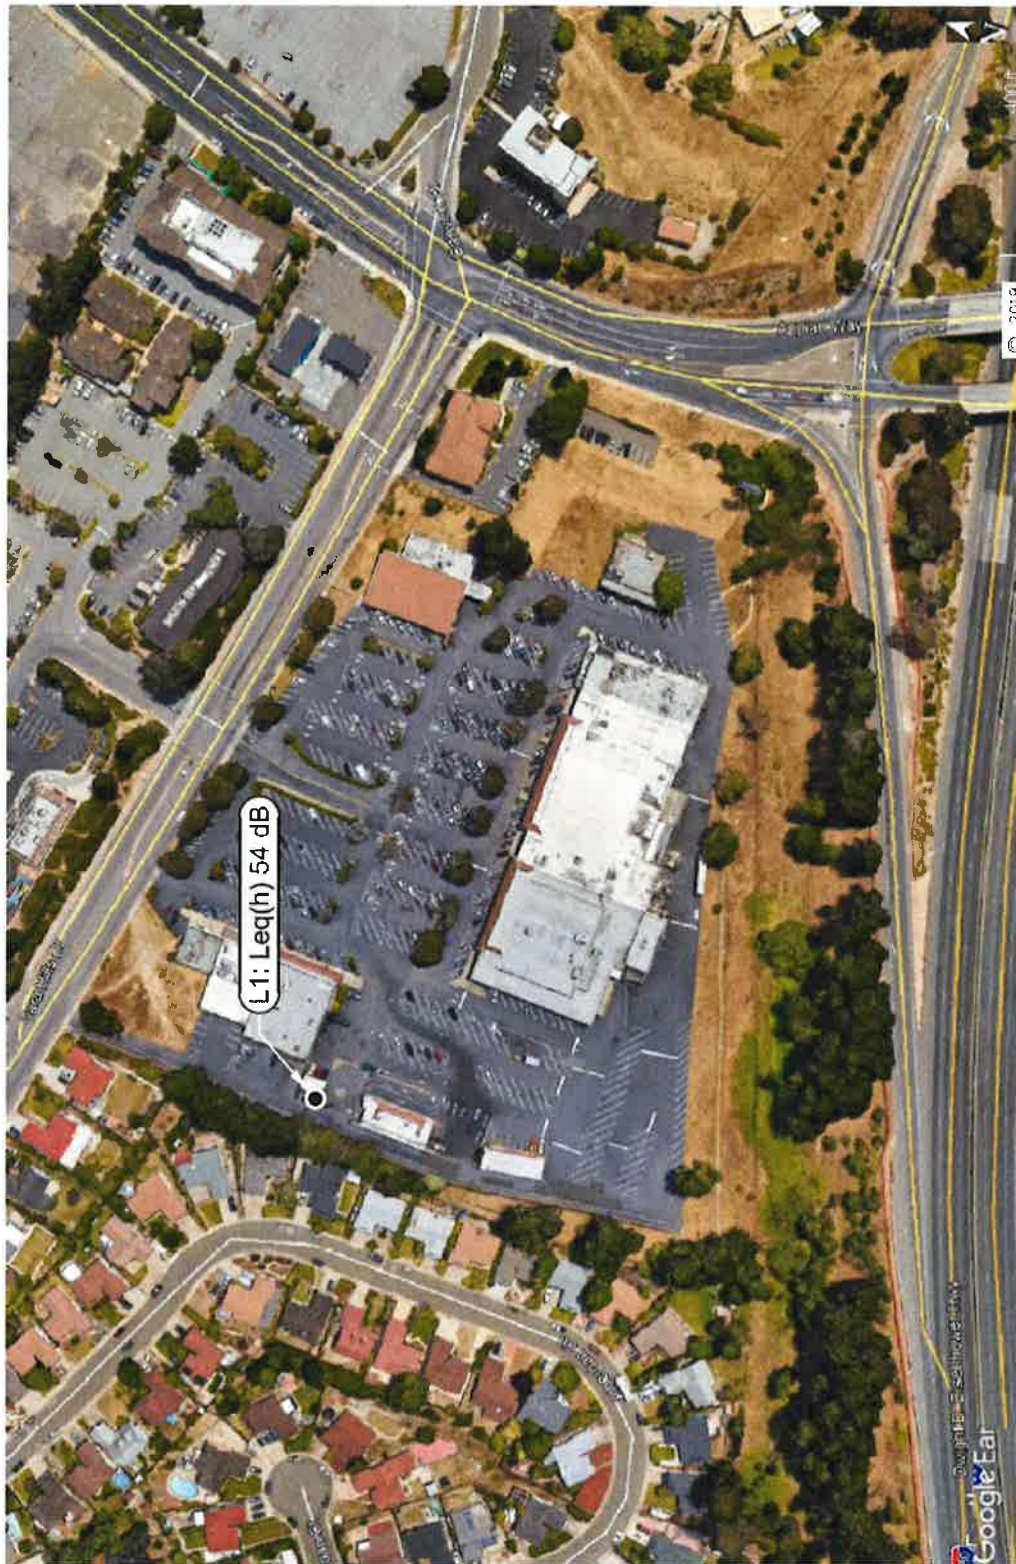
FIGURE 1

APPLAN 80 SHOPPING CENTER
MEASUREMENT LOCATIONS AND MEASURED
NOISE LEVELS

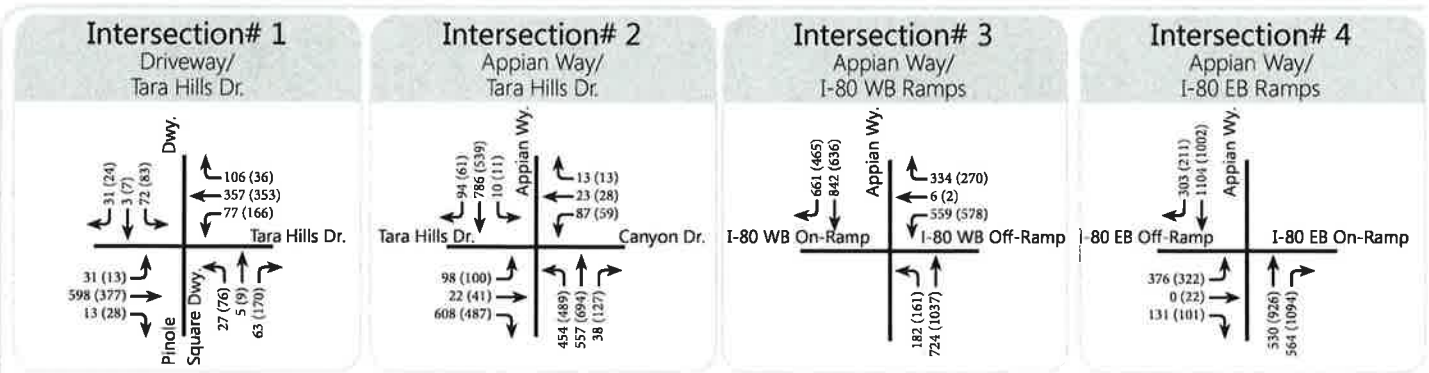
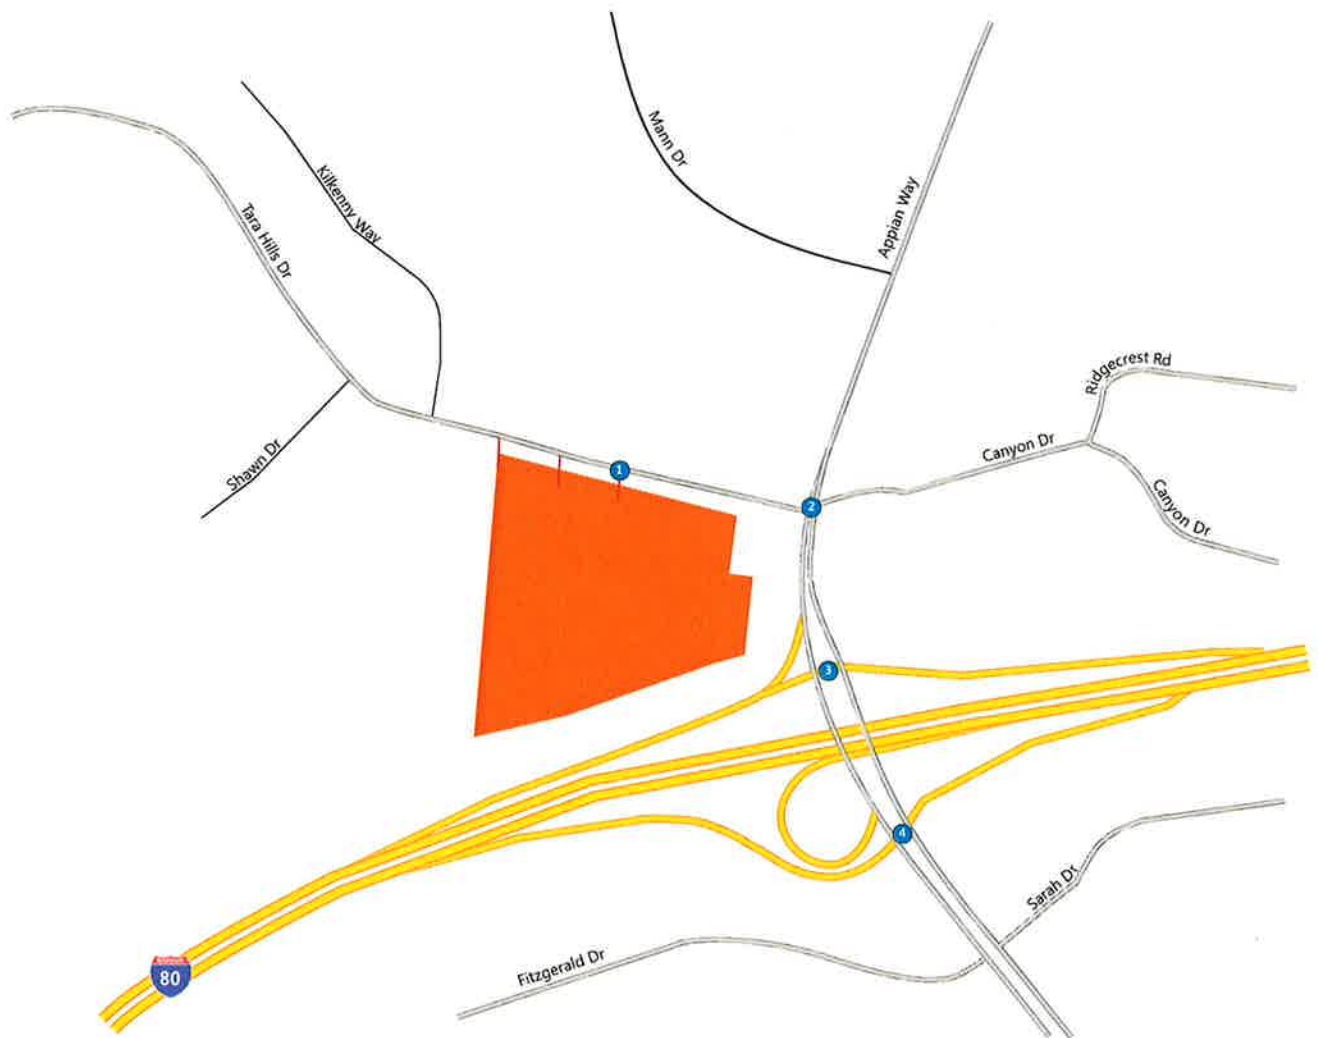
Figure 6: Existing Conditions Volumes

The existing operations of the study intersections were evaluated for the highest one-hour volumes during weekday morning and evening peak periods. Recent turning movement counts for vehicles, bicycles, and pedestrians were conducted during the weekday a.m. peak period (7:00-9:00 a.m.) and p.m. peak period (4:00-6:00 p.m.) at the study intersections on typical weekdays in June of 2019 when school was in session.
