**CITY OF PINOLE  
SEWER MASTER PLAN  
MAY 2008**

**SEWER MASTER PLAN**

**CITY OF PINOLE**  
**SEWER COLLECTION SYSTEM**  
**MASTER PLAN**

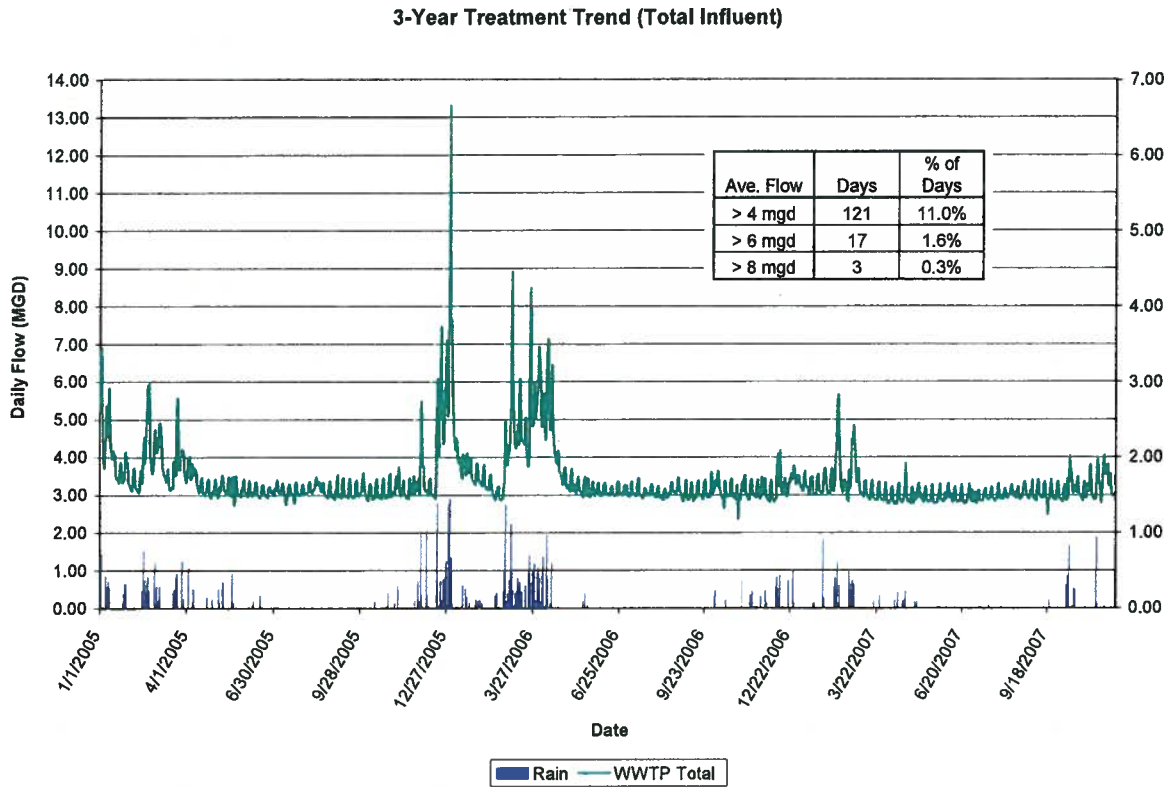
**Figure ES - I WWTP Flow Measurements**

As shown, the Total Flow into the WWTP (from Pinole and Hercules) increases greatly during rainfall events and returns to normal flows within a day or two. This increase and rapid return to normal indicates significant inflow defects in the collection systems. Note that this chart plots daily volume and not the peak rates that have occurred.

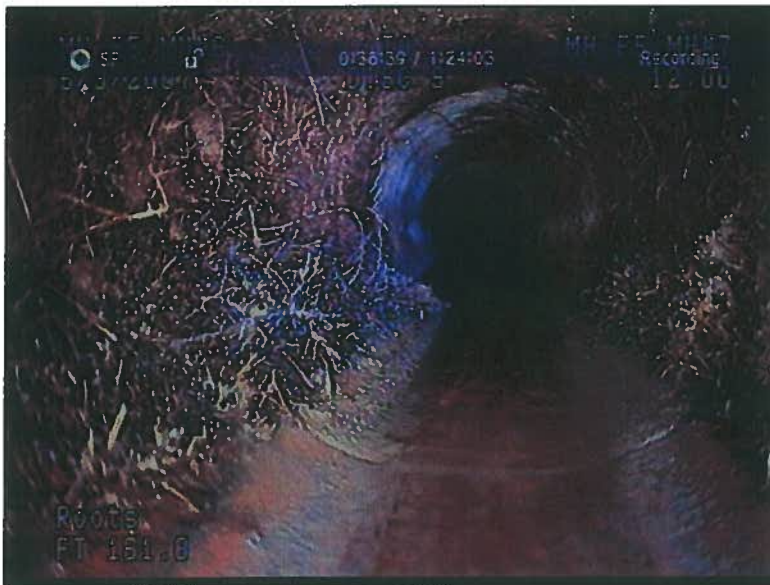
Figure ES - 3 CCTV Results (Root Intrusion)

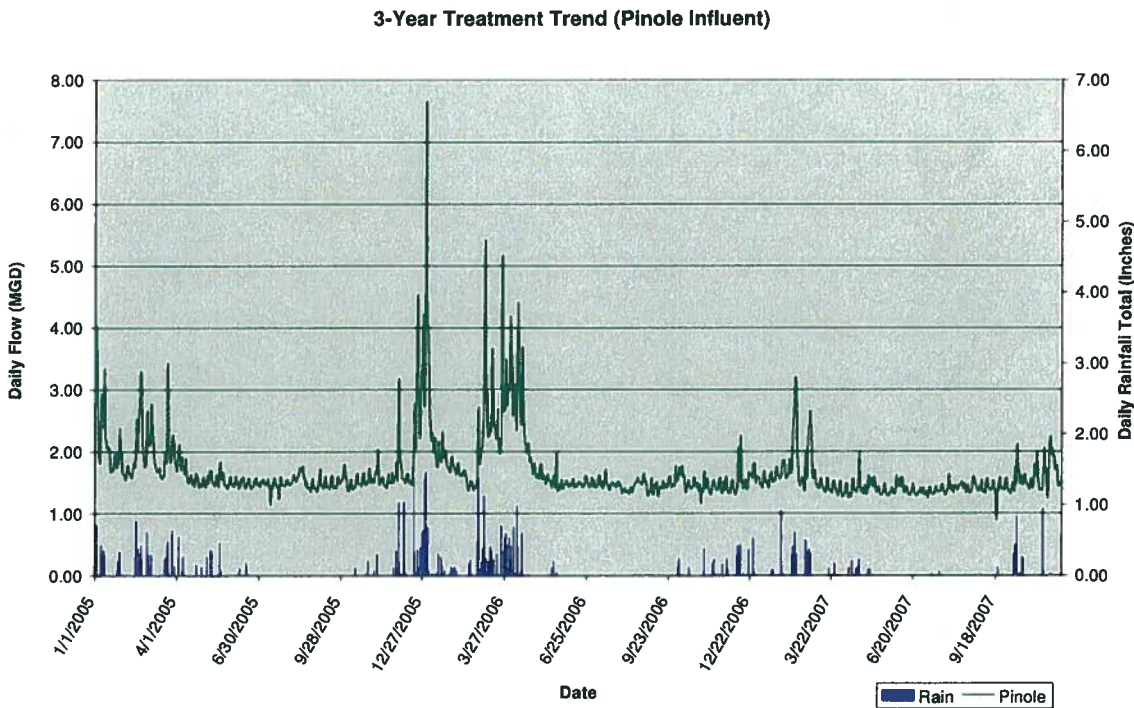
Figure 6-1 WWTP Historical Daily Flow Volume (Pinole Only)

From this graph it is easily observed that there is a significant impact of rainfall events on the treatment plant inflow. It also shows that there is little change in the dry weather flows during this three year period. The WWTP data was combined with the Flow Measurement Program

Based on this data it was observed that the total volume of flow entering the Treatment Plant from Pinole is about 1.7 million gallons per day (mgd) during dry weather conditions. As Figure 6-1 shows, the rainfall event of 12/31/2005 resulted in a daily volume of 7.6 million gallons. This would indicate that almost 6.0 million gallons of rainfall entered the sewer collection system and was conveyed to the plant. The calculated wet weather peaking factor for daily volume is  $7.6 \text{ MGD}/1.7 \text{ MGD} = 4.5$ . Note that the Peaking Factor for Peak Rate could not be calculated due to inoperable flow meters during the 12/31/2005 event.

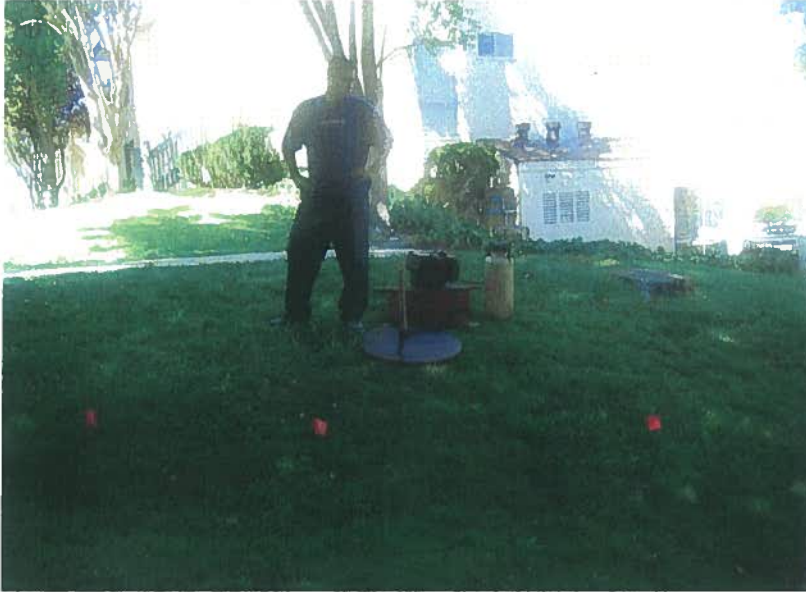
Figure 6-3 shows orange flags where smoke was observed. Note that this is a private lateral that appears to be leaking at each joint. Also notice the depression in the ground (left of photograph) that probably indicates that some subsidence has occurred and that rainwater collects at this low point. The location of positive smoke identified inflow defects in Basin 6 is shown in the following photos.

Figure 6-3 Private Lateral Positive Smoke

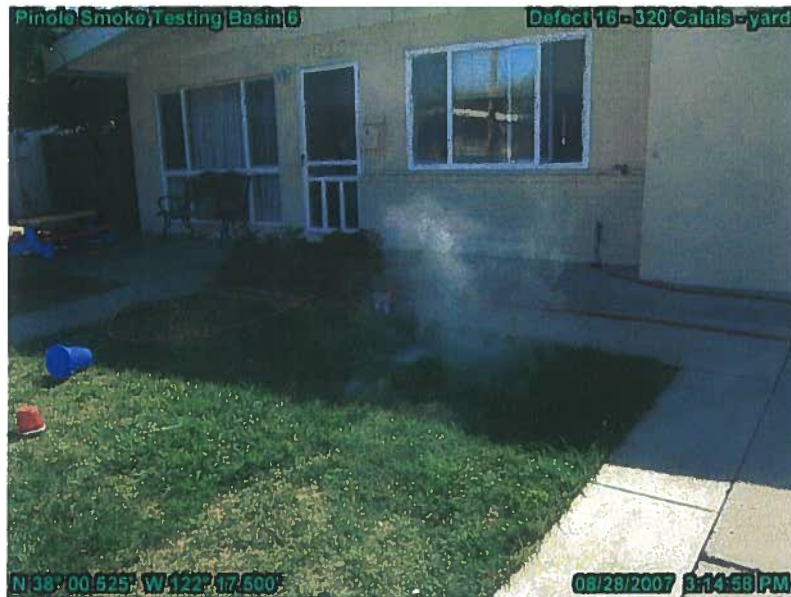
Figure 6-4 Private Lateral Smoke

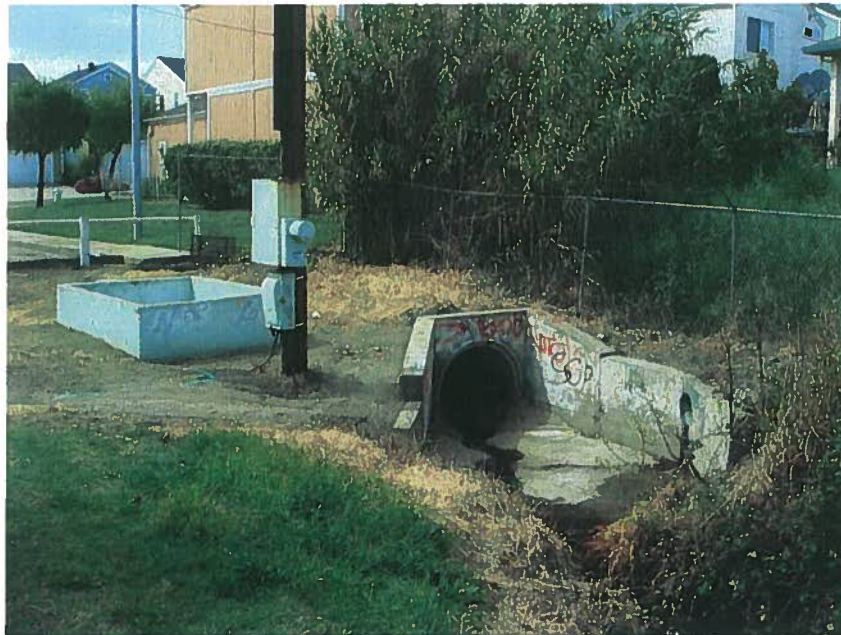
**Figure 6-10 Hazel Street Pump Station**

Based on calibrated flows, capacity analyses performed on the collection system show that the pipes coming into the Hazel Street are also overloaded. Additionally, the downstream flows surcharge the system under wet weather condition. A complete Pump Station Elimination study should be commenced to look at possible elimination of both the San Pablo and Hazel Street Pump Stations through the use of trenchless technologies. It is likely that the operations and maintenance cost savings would be significant.

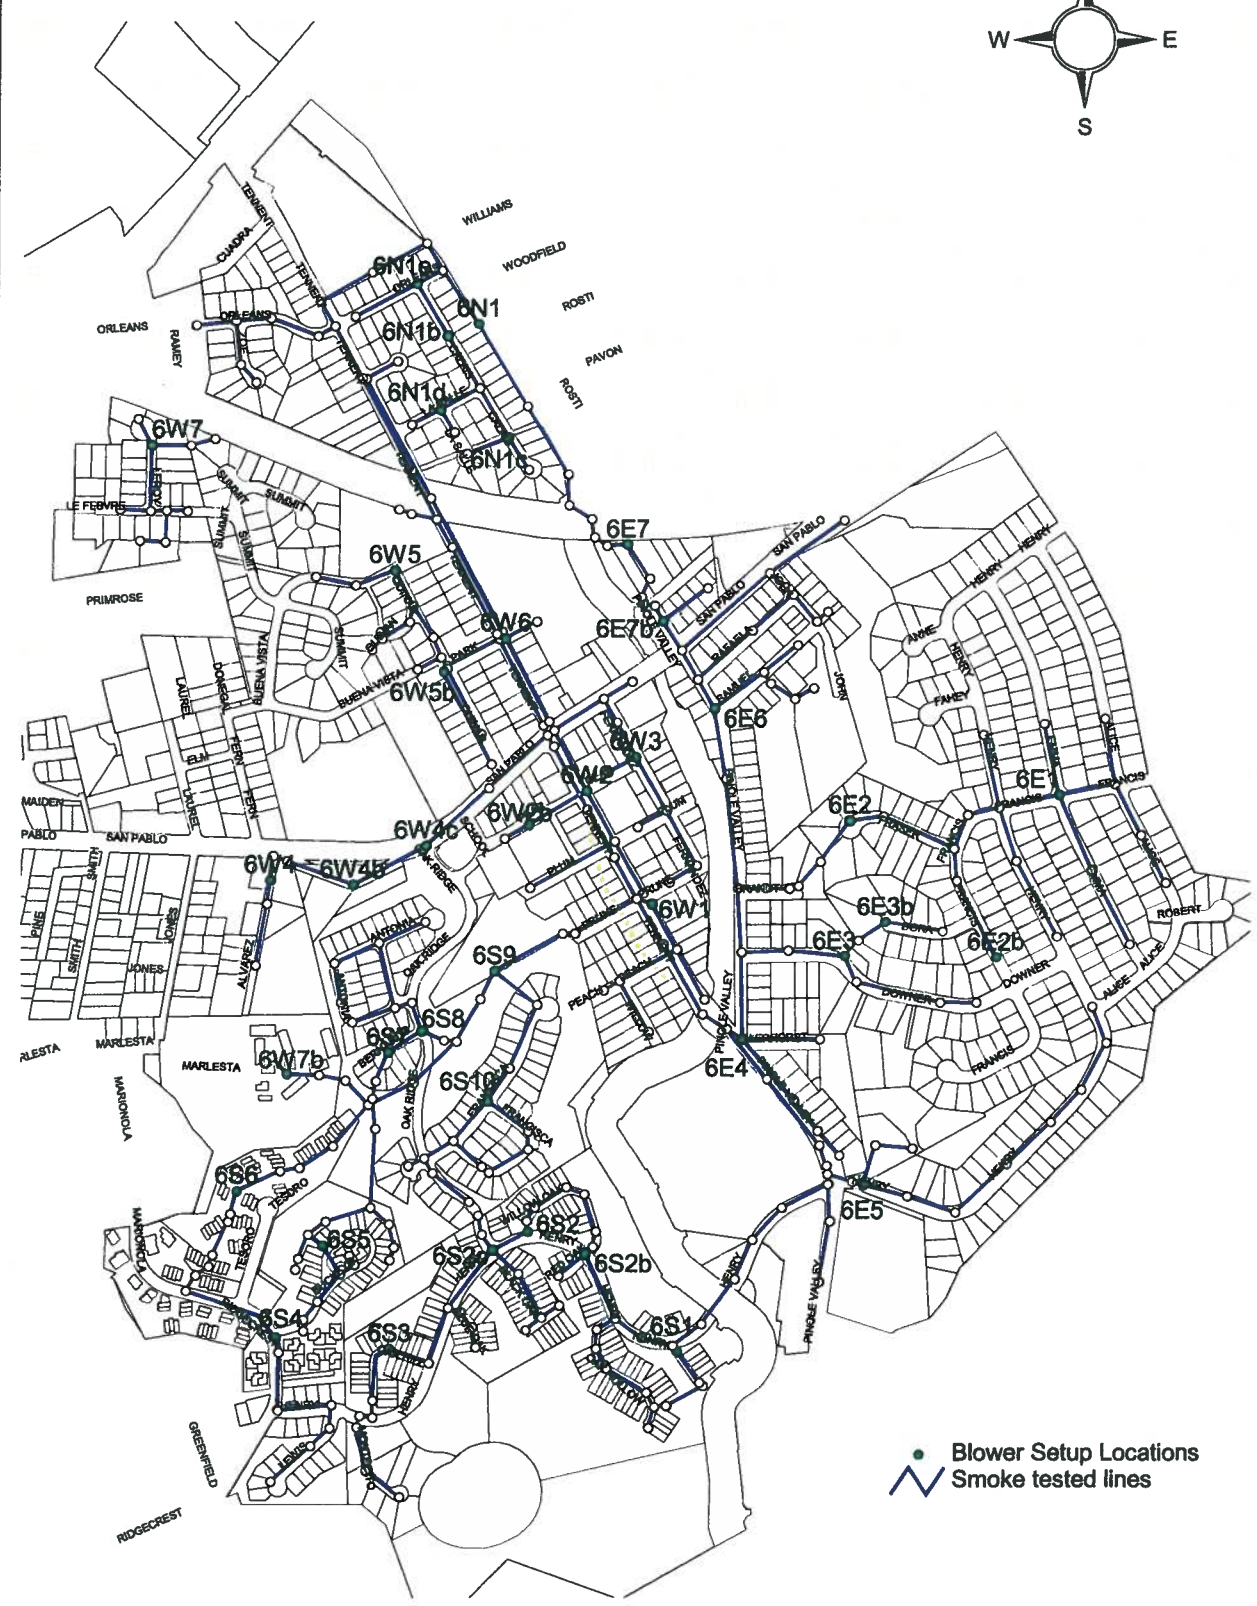
Figure 1  
Map of Smoke Tested Lines  
Basin 6  
City of Pinole - 2007

The map in Figure 1 shows the smoke testing piping within basin 6 along with the 39 smoke setup locations.

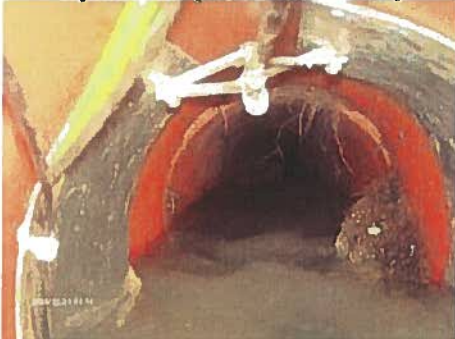
<p><b>Upstream (Root Intrusion)</b></p>
