**PRELIMINARY GEOTECHNICAL INVESTIGATION
THE BCRE PROJECT
2801 PINOLE VALLEY ROAD
PINOLE, CALIFORNIA**

November 1, 2021

Job No. 3039.001

Prepared for:
Pinole Valley Partners, LLC
c/o Brian Baniqued
2801 Pinole Valley Road, Suite 201
Pinole, California 94564

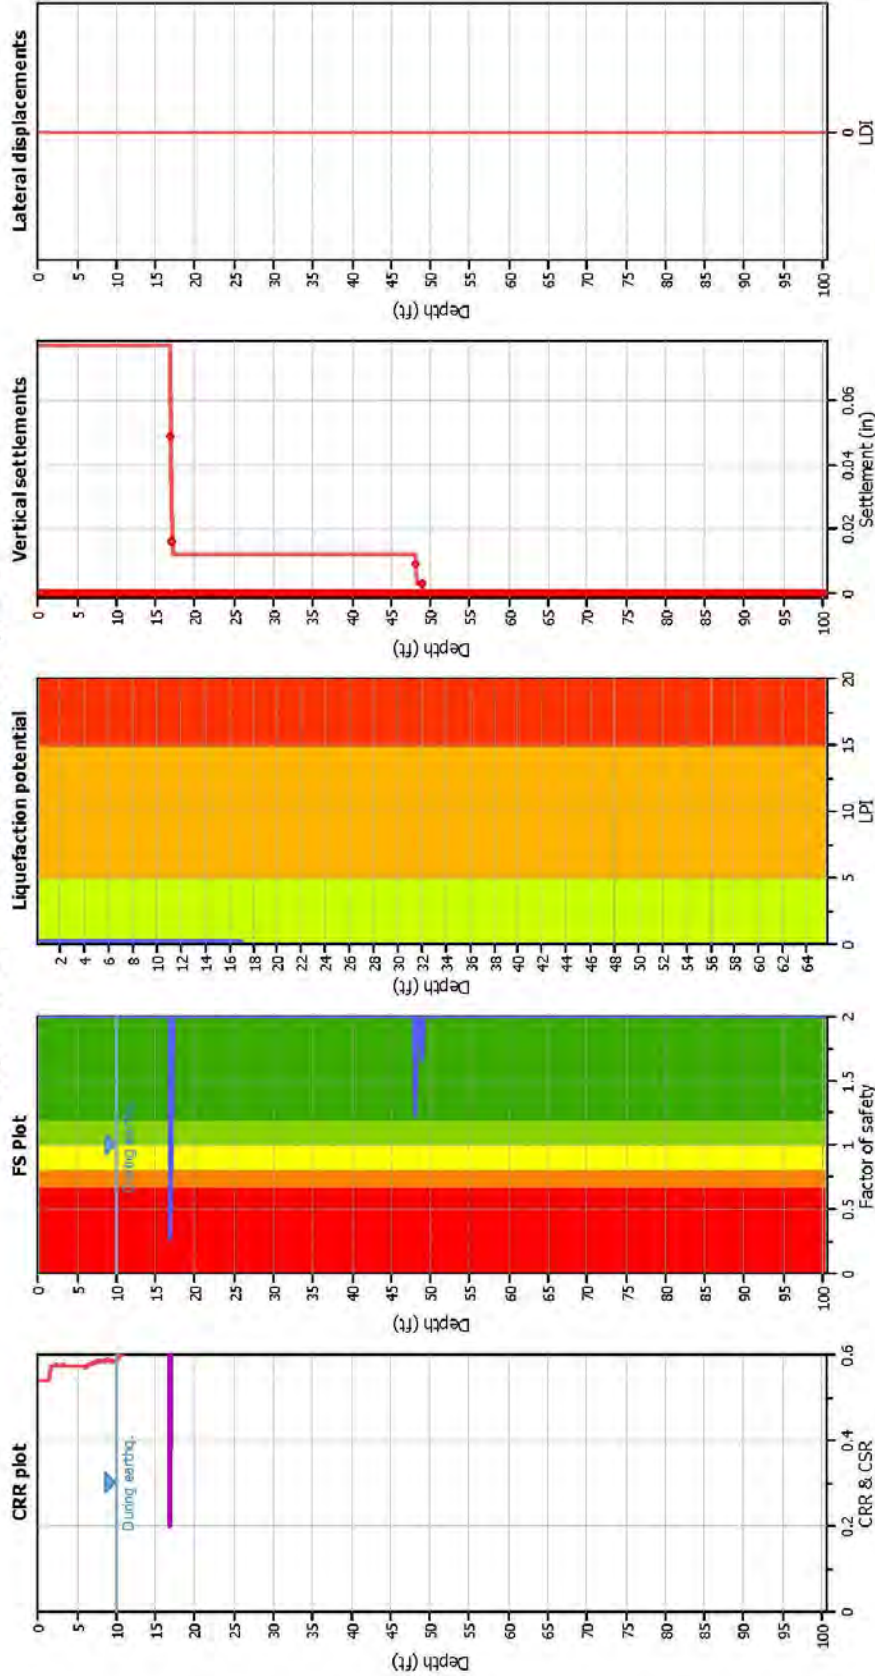
8
 FIGURE

LPI color scheme
 Very high risk (Red)
 High risk (Orange)
 Low risk (Yellow)

F.S. color scheme
 Almost certain it will liquefy (Red)
 Very likely to liquefy (Orange)
 Liquefaction and no liq. are equally likely (Yellow)
 Unlikely to liquefy (Green)
 Almost certain it will not liquefy (Dark Green)

Liquefaction analysis overall plots
