# CITY OF PINOLE SEWER FLOW MONITORING & INFLOW/INFILTRATION STUDY

Prepared for: **City of Pinole**  
2131 Pear Street  
Pinole, CA 94564

Date: August 2015

V&A Project No. 13-0276

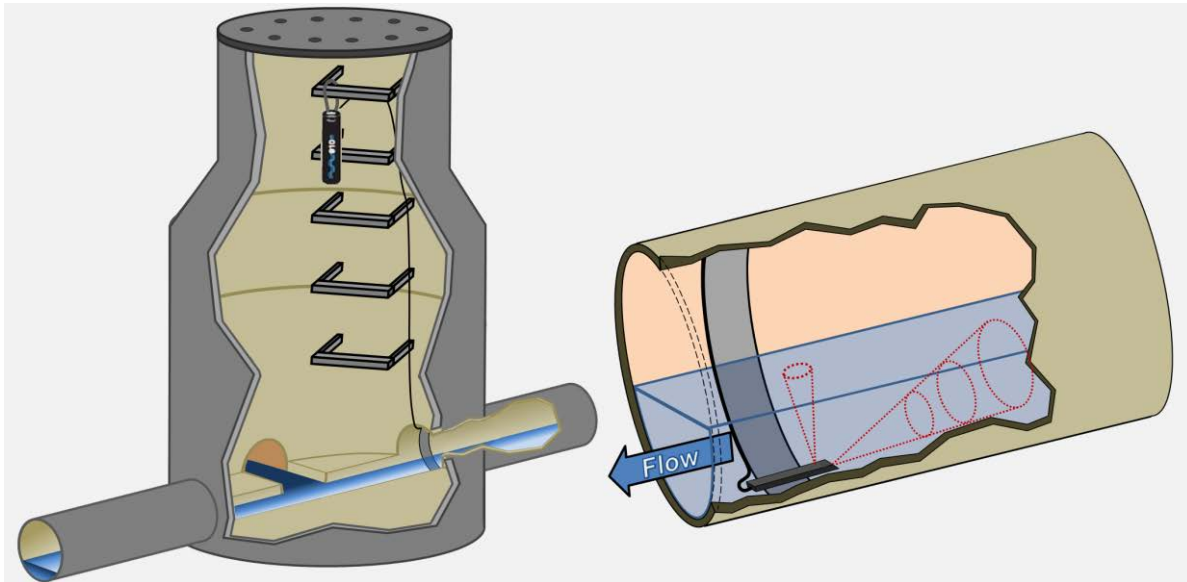
Isco 2150 meters use submerged sensors with a pressure transducer to collect depth readings and an ultrasonic Doppler sensor to determine the average fluid velocity. The ultrasonic sensor emits high-frequency sound waves, which are reflected by air bubbles and suspended particles in the flow. The sensor receives the reflected signal and determines the Doppler frequency shift, which indicates the estimated average flow velocity. The sensor is typically mounted at a manhole inlet to take advantage of smoother upstream flow conditions. Figure 2-1 shows a typical installation for a flow meter with a submerged sensor.

**Figure 2-1. Typical Installation for Flow Meter with Submerged Sensor**

The pipe diameter was verified in order to accurately calculate the flow cross-section. In-situ manual (hand) level and velocity measurements were taken and compared to simultaneous level and velocity readings from the flow meters to ensure proper calibration and accuracy. This determination of the level offset is required because of variations in individual flow meters, position of the sensor upon installation, thickness of the mounting band and other factors.

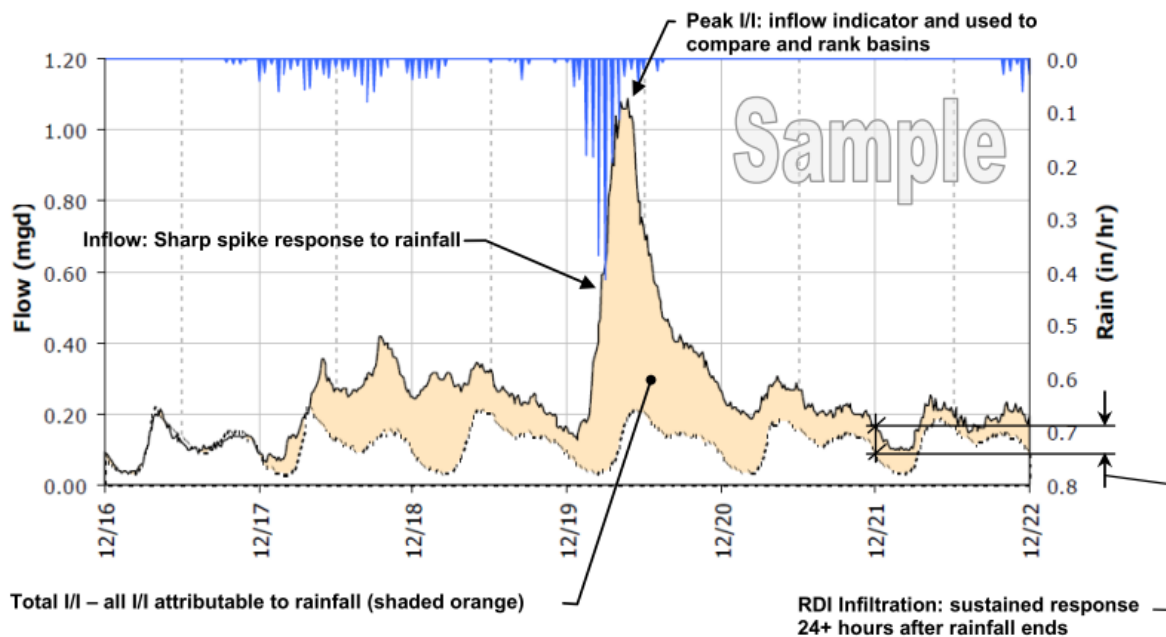
Inflow is usually recognized graphically by large-magnitude, short-duration spikes immediately following a rain event. Infiltration is often recognized graphically by a gradual increase in flow after a wet-weather event. The increased flow typically sustains for a period after rainfall has stopped and then gradually drops off as soils become less saturated and as groundwater levels recede to normal levels. Real-time flows were plotted against average dry weather flow (ADWF) to analyze the I/I response to rainfall events. Figure 2-7 illustrates a sample of how this analysis is conducted and some of the measurements that are used to distinguish I/I. Similar graphs were generated for the individual flow monitoring sites and can be found in *Appendix A*.

Figure 2-7. Sample Infiltration and Inflow Isolation Graph

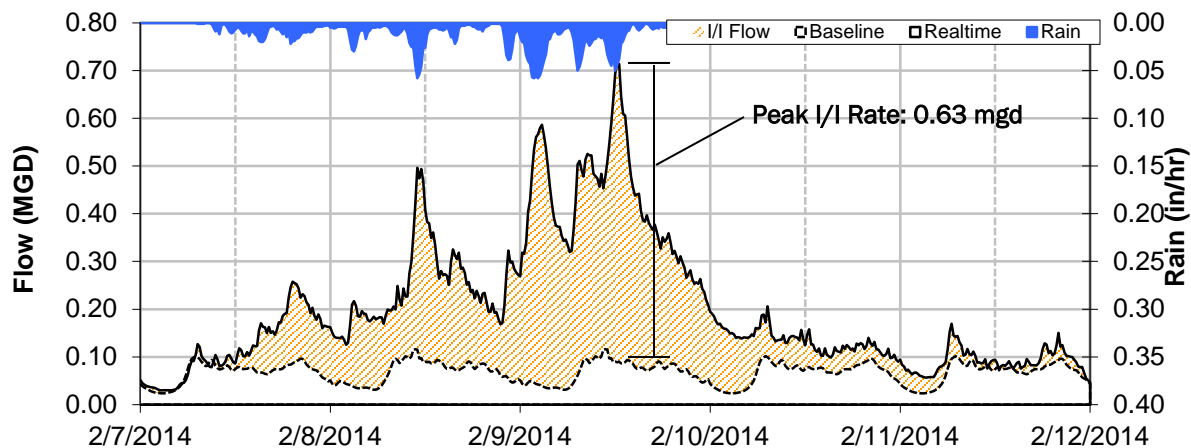
Figure 5-1 illustrates the I/I response curve for Basin 3 and Storm Event 1 as it relates to peak I/I rate.

Figure 5-1. I/I Isolation Curve, Basin 3 (Inflow Measurement)

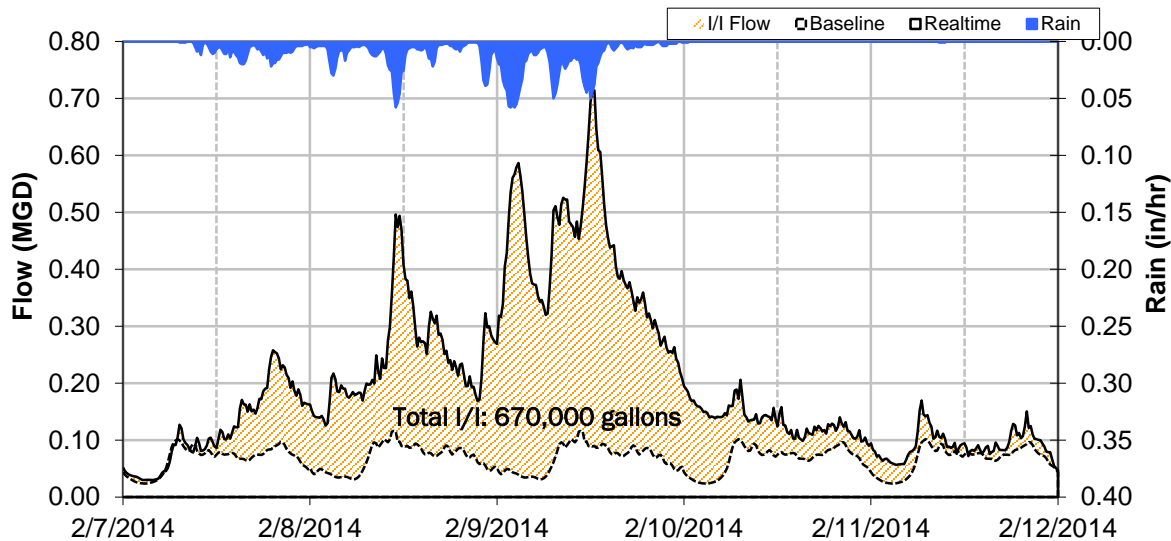
Combined I/I analysis considers the totalized volume (in gallons) of both inflow and rainfall-dependent infiltration over the course of a storm event. For example, the total volume of infiltration and inflow into Basin 3 for the February 7 - 12, 2014 storm event calculated out to 670,000 gallons (hatched area below in Figure 5-3).

Figure 5-3. I/I Isolation Curve, Basin 3 (Combined I/I Measurement)
